DATE: November 10, 2023

PRODUCT: 2021 DXL K-Series

TITLE: Pilot adhesive change

MODELS AFFECTED: DXL-060K thru DXL-235K

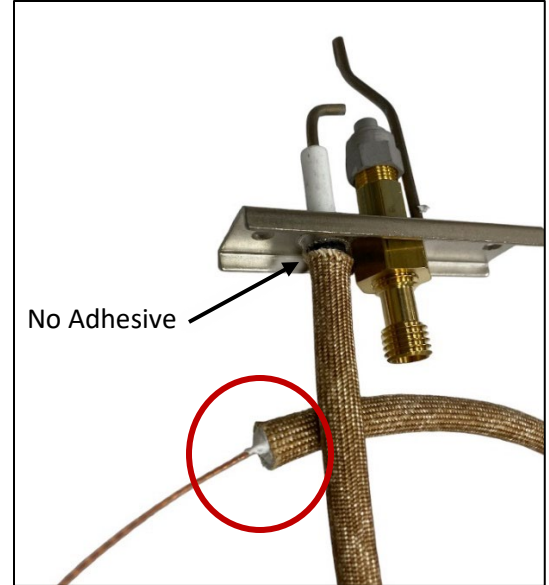
To prevent any possible electrical continuity between the ignitor and ground the adhesive used to hold the fiberglass sleeve in place has been moved from the ignitor to the other end of the sleeve. This was a rolling change implemented in March of 2023. See photos 1 & 2.

Photo 2: New location of adhesive
